FINAL 2006 CLEANUP STATUS REPORT VELSICOL CHEMICAL/PINE RIVER SITE

St. Louis, Michigan

Phase 2 Remedial Action

December 2006

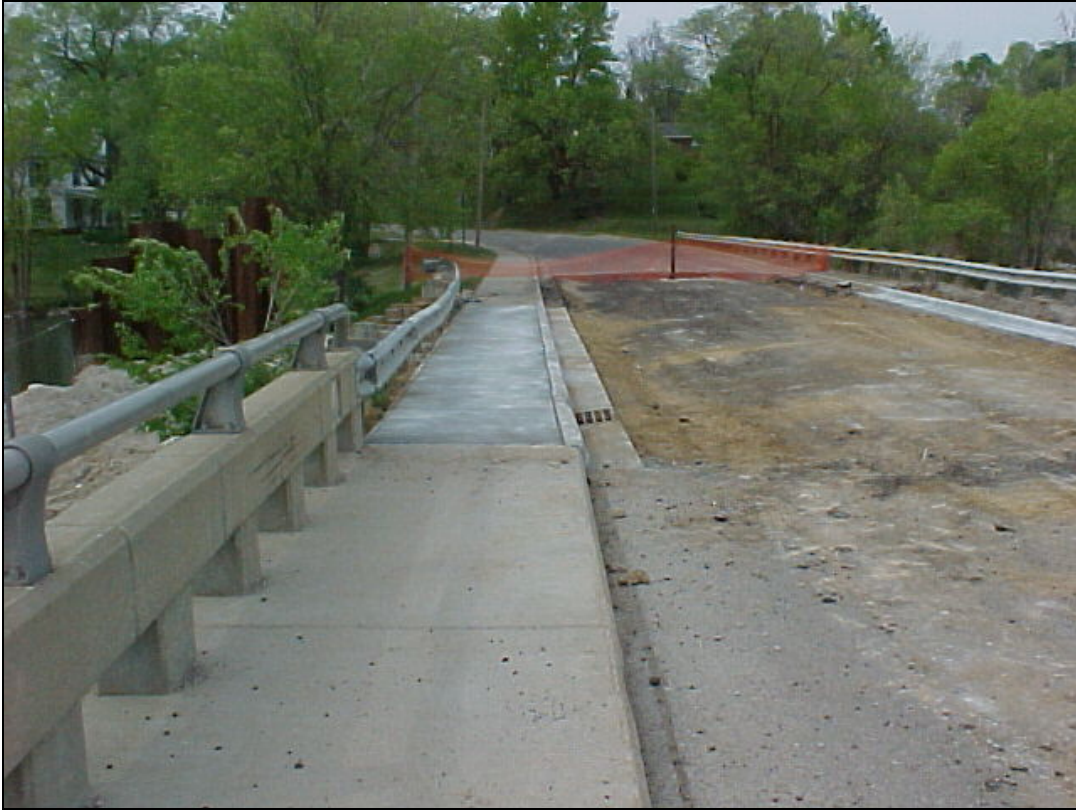
PHOTO 7—Previously damaged sidewalk after replacement in May 2006.

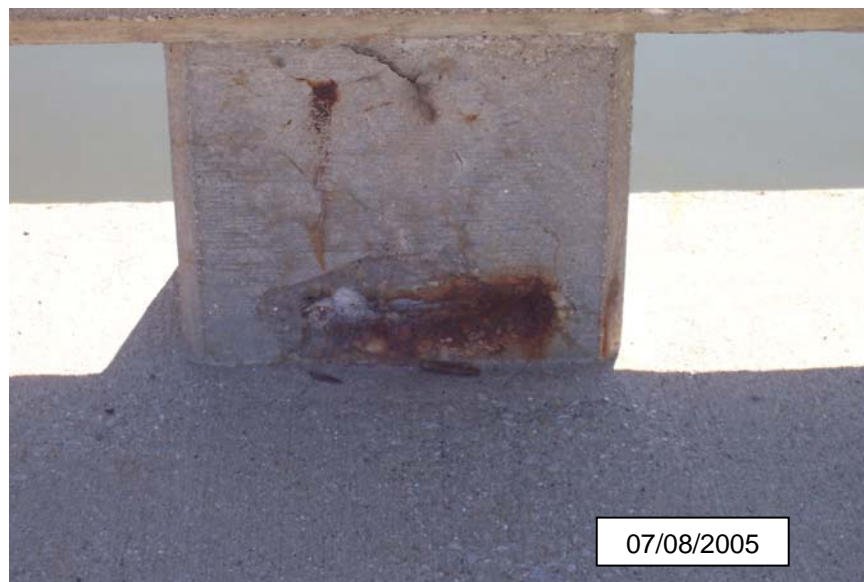
Photograph 22 - Representative parapet base spalling

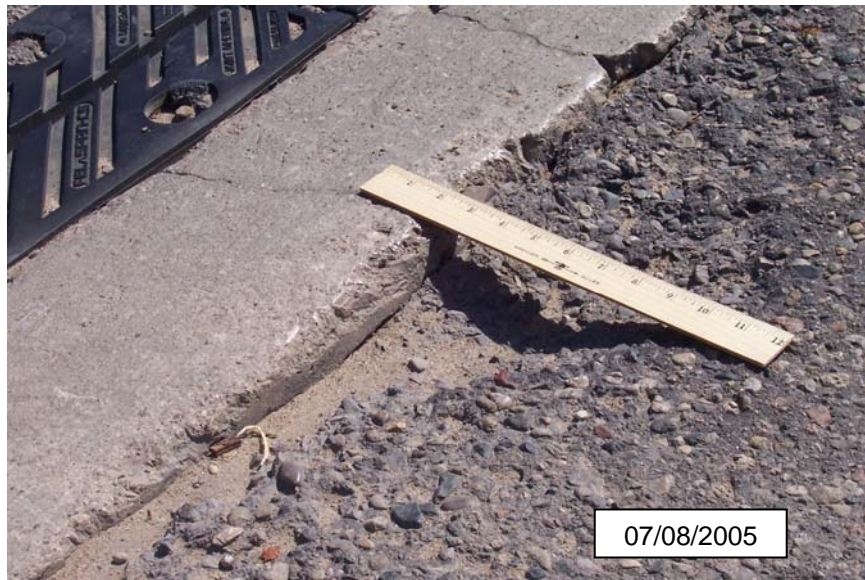
Photograph 23 - Asphalt condition at Pier 2 Expansion Joint

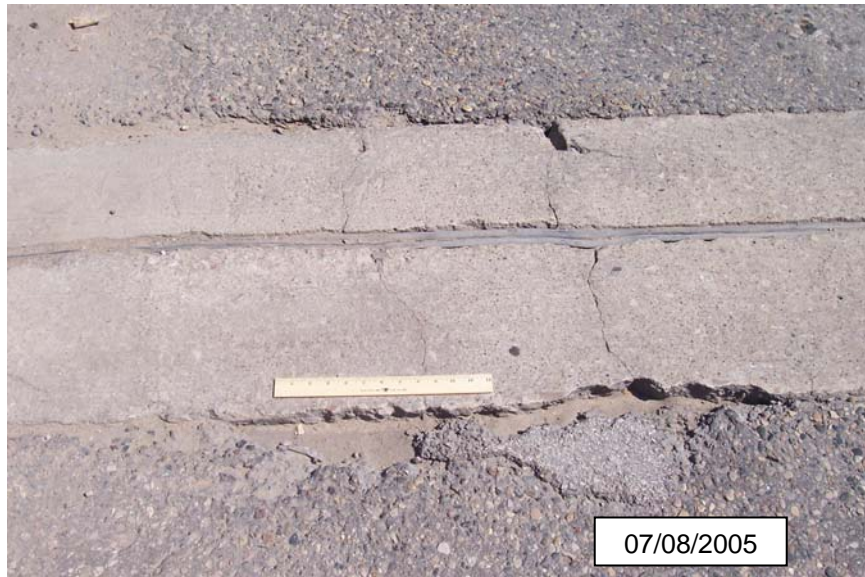
The expansion joint at pier 1 remains in fair to poor condition, and the expansion joint at pier 2 remains in good condition.

Photograph 24 - Asphalt condition at Pier 1 Expansion Joint

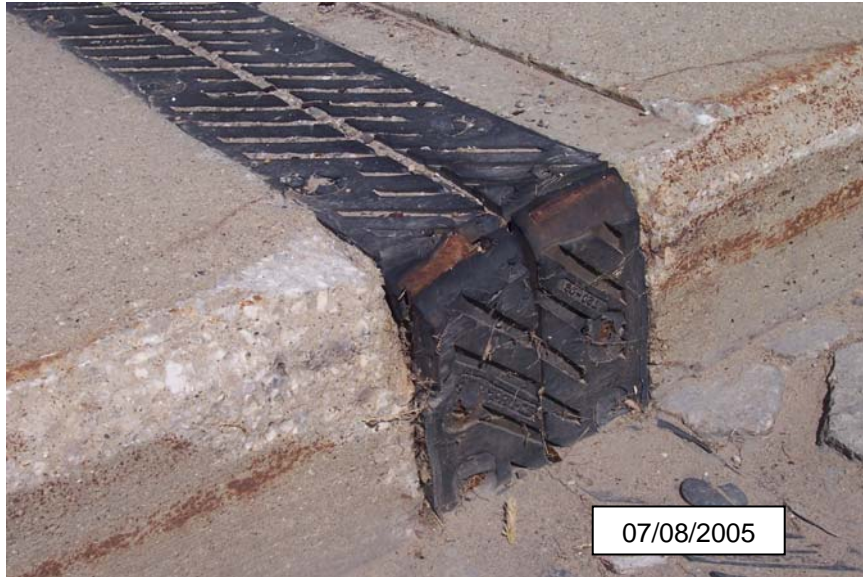
Photograph 25 - Pier 2 expansion joint damage

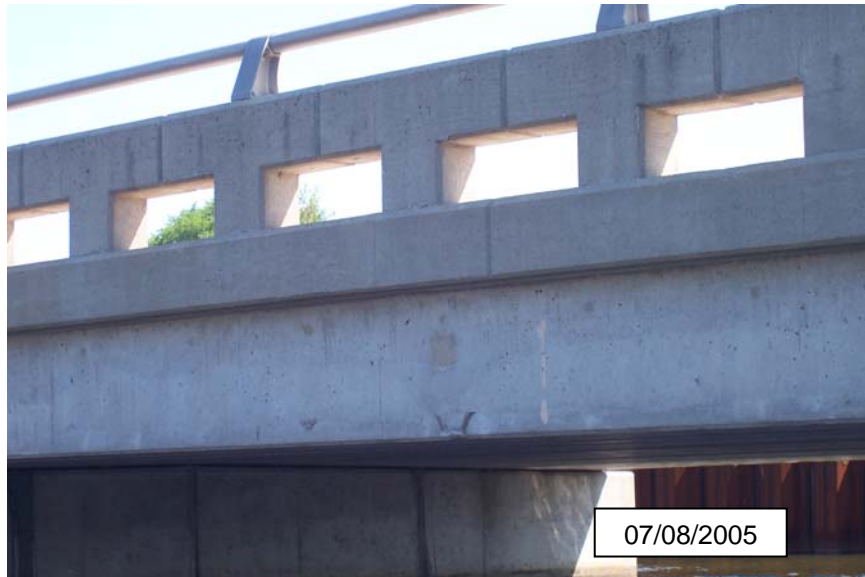
Photograph 28 - Damage at Span 2, west fascia beam

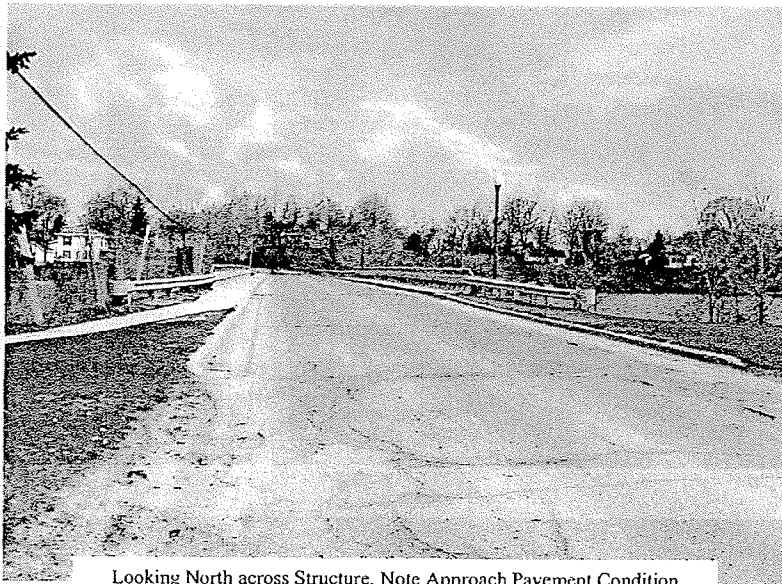
Looking North across Structure, Note Approach Pavement Condition
