FINAL 2006 CLEANUP STATUS REPORT VELSICOL CHEMICAL/PINE RIVER SITE

St. Louis, Michigan

Phase 2 Remedial Action

December 2006

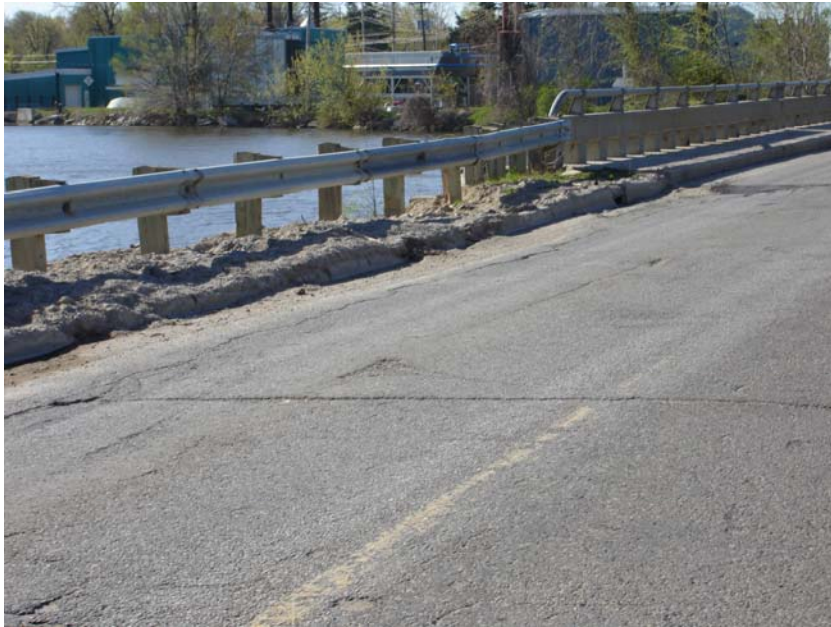
Photograph 5 - Northeast curb and guardrail removed

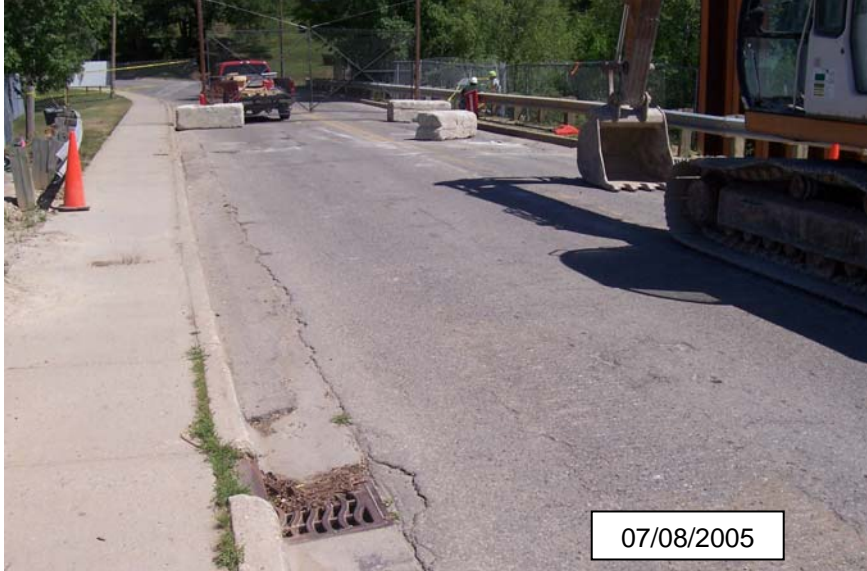
Pavement on both the north and south approaches is significantly cracked and deteriorated (Photographs 4 and 3, respectively). In several areas the patched asphalt has failed, resulting in holes through the top course (see Photograph 21). Vegetation has grown up through the cracked joint at the south abutment.

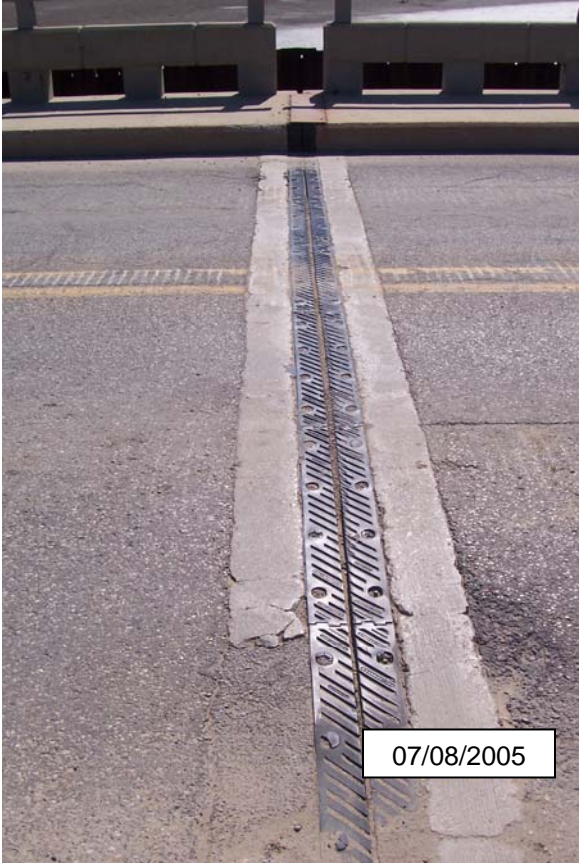
Photograph 6 - Expansion Joint at Pier 2

The expansion joint at pier 2 is in good condition (Photograph 6), with some damage at the west curb (see Photograph 25). Pier 1 has an older expansion joint and is in fair to poor condition (see Photograph 8). The concrete in the expansion joint blockouts is cracked and the abutting asphalt is cracked and patched (see Photographs 23 and 24). Full-width cracking was noticed at the north and south abutment and patches in the asphalt are present.

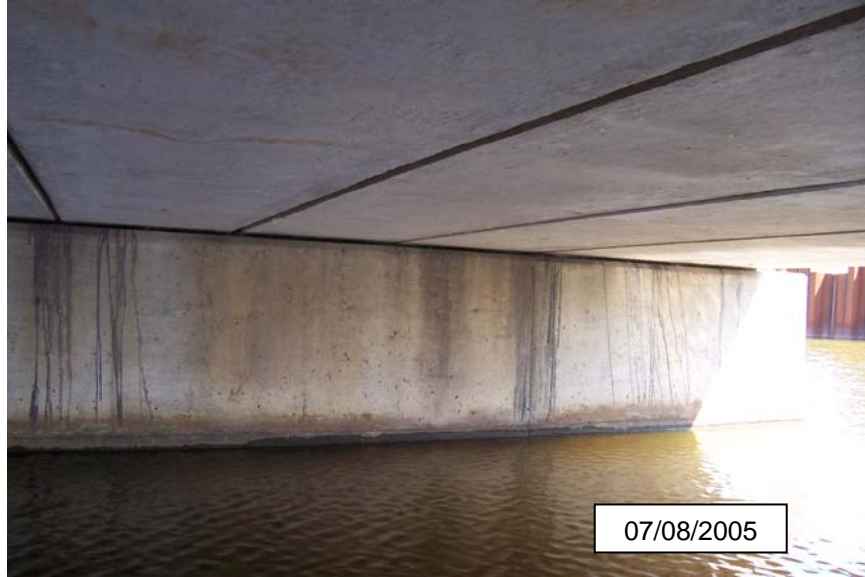
Though a detailed inspection could not be completed due to the high water level, the box beams appear to be in good condition based on the visual inspection (Photographs 11, 14, and 17). At the midspan of span 2, the west fascia beam has an area of cracked and spalled concrete on the fascia (Photograph 28). The condition rating of '7' for the beams is accurate.

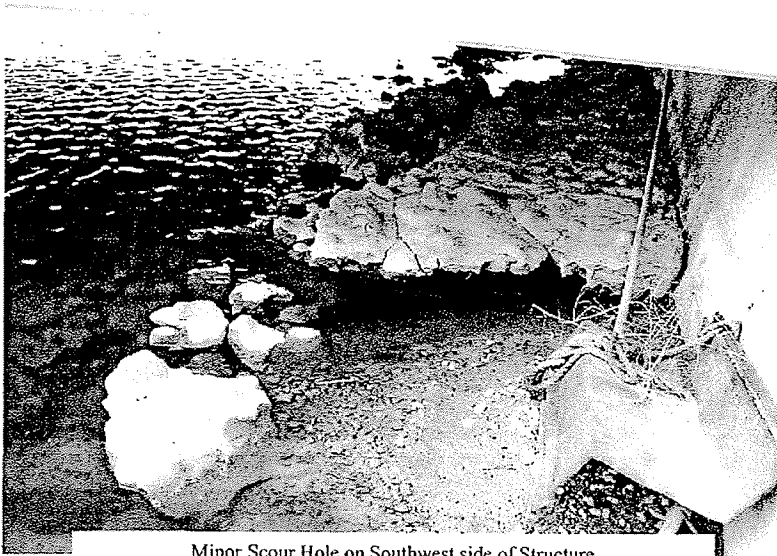
Minor Scour Hole on Southwest side of Structure

Deck Patching												
Approach Pavement	H	Re-surface approach pavement										
Joint Repair												
Railing Repair												
Detailed Insp												
Zone Paint												
Substr. Repair	M	Fill small scour hole at SW quadrant with rip-rap.										
Slope Repair												
Brush Cut												
Other Crew Work												
Bridge Replacement												
Superstructure Replacement												
Deck Replacement												
Overlay	H	Re-Surface Bridge										
Widen												
Paint												
Zone Paint												
Pin and Hanger												
Substructure Repair												
Other Contract Work
